DENSO CoGeneration | GE3-5 Iridium Saver Spark Plug

DENSO have been made aware of an imitation GE3-5 Iridium Saver Spark Plug. If you experience poor lifetime or experience spark plug issues, please check that you have a genuine DENSO component. Please look out for the following differences which will have a dramatic effect on the lifetime, and possibly may have severe affects on the engine durability.

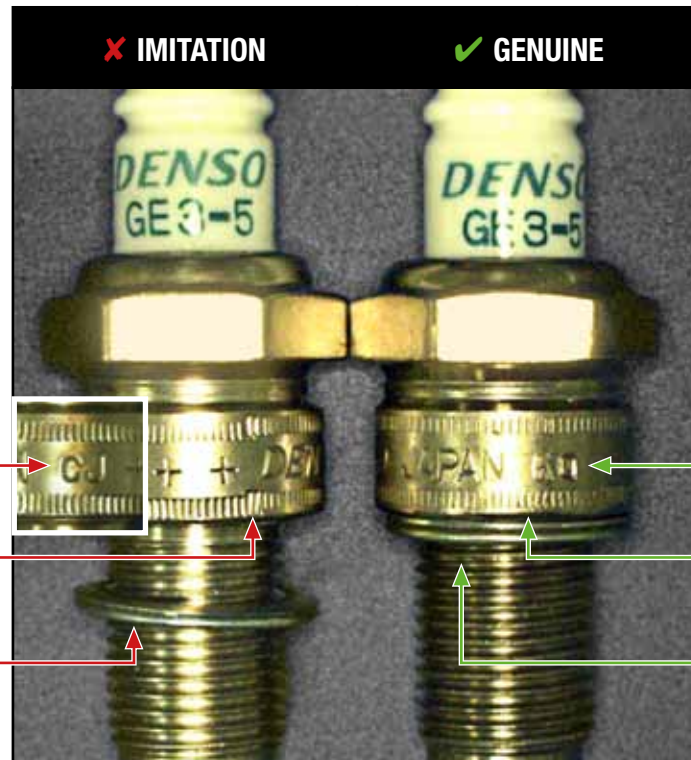
MONTH	YEAR
B	January	J 2007
C	February	K 2008
D	March	L 2009
E	April	M 2010
F	May	N 2011
G	June	P 2012
H	July	Q 2013
J	August	R 2014
K	September	S 2015
L	October	T 2016
M	November	U 2017
N	December	B 2018

✗ Un-realistic date stamp code:
CJ > Februari 2007

✓ Realistic date stamp code:
KQ > September 2013

✗ Poor stamping on housing

✓ Good stamping on housing

✗ Sealing washer tight on thread
(On the fake plug the sealing washer can move freely up and down the thread)

✓ Sealing washer tight on thread
(On DENSO plug the sealing washer can not move up and down the thread)

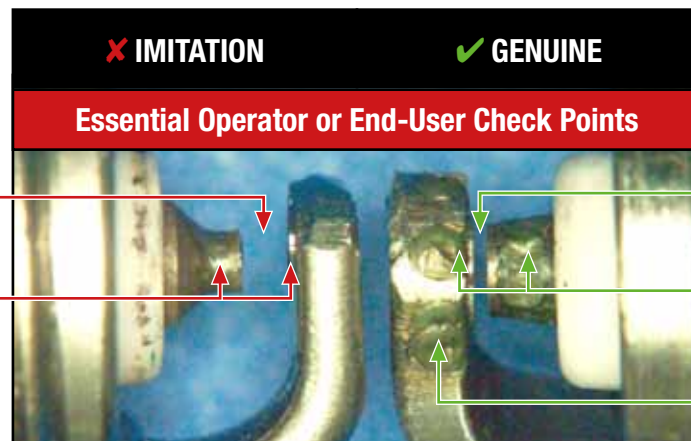
✗ Too large electrode air gap:
0,9mm

✓ Correct electrode air gap:
0,3mm

✗ Small electrode sizes:
1,3mm / 2,0mm

✓ Correct electrode sizes:
2,0mm / 2,4mm

Correct weld technique
